# **Nyadi Hydropower Limited**

## **Nyadi Hydropower Project (30 MW)**

### **Progress Report**

(May 2021)

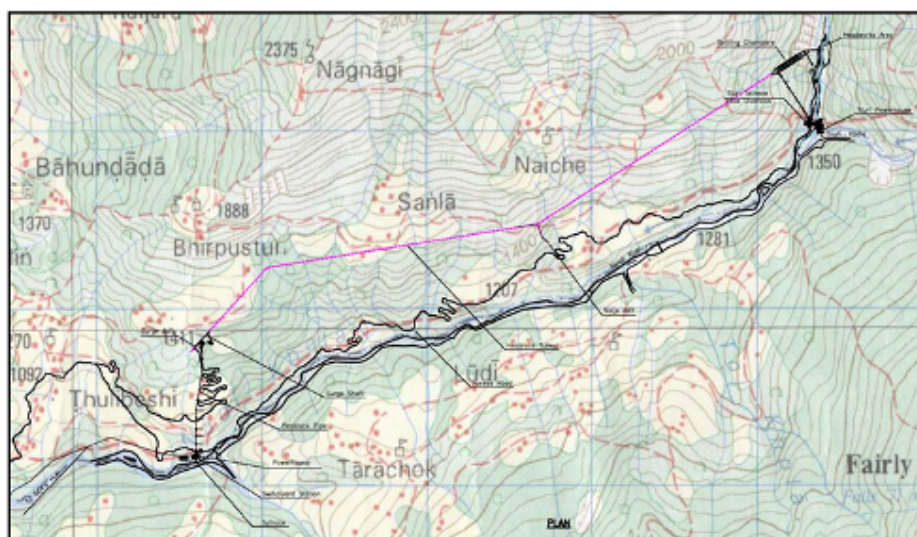
Figure1: General Project Layout of Nyadi Hydropower Project

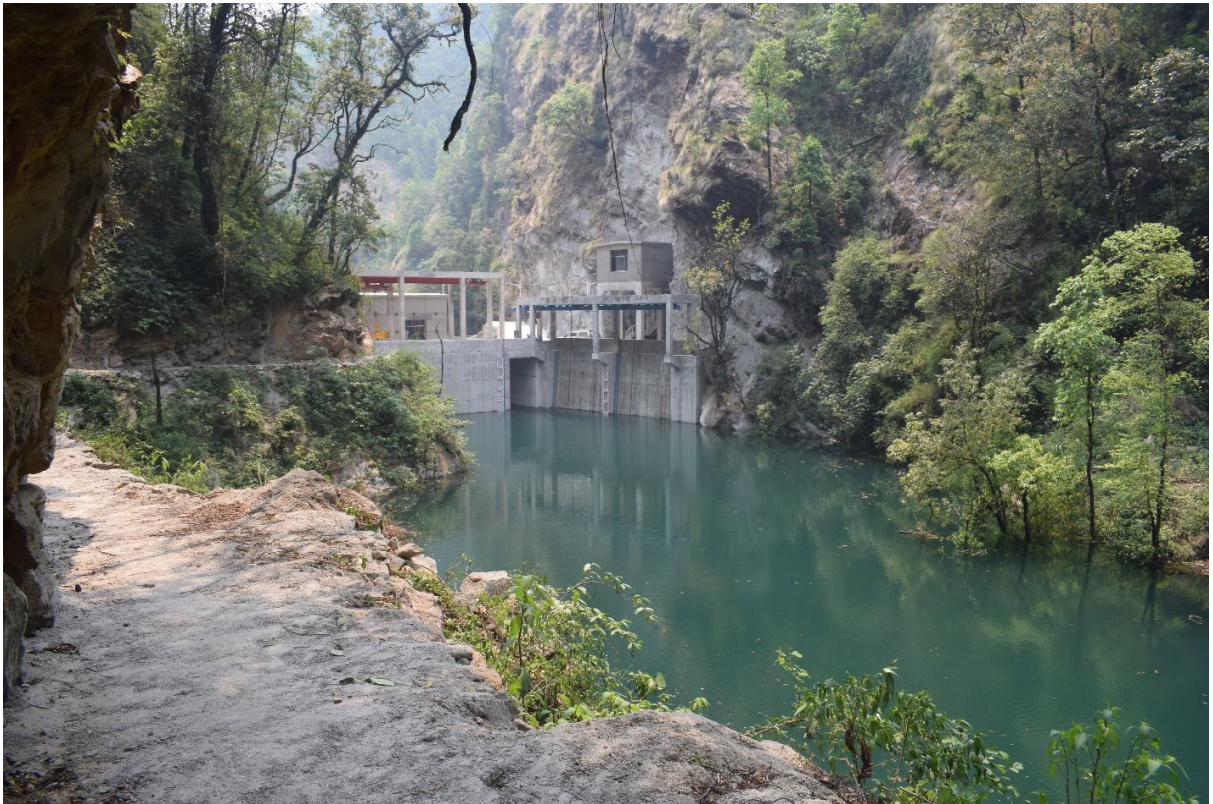
Figure 2: Water Filling at Headworks for Testing of Gates and Stoplogs

Excavation and concreting of first cut-off wall up to level 1372.00 m at dam site have been completed. Concreting of second cut-off wall and downstream cut-off wall up to level 1372.00 m have been completed. Likewise, a submerged sand trap at upstream of first cut-off wall up to level 1374.00 m and intermediate submerged sand trap wall up to 1381.00 m has been completed. Retaining wall of stilling basin at right bank of river up to level 1381.00 m has been completed. Curtain grouting work at first cut-off wall has also been completed. Grouting at both side of dam axis between first and second cut off wall has been completed. Concreting up to level 1398.00m at stop logs and radial gates section of Dam has been completed. Brick work at the control room and hoist room of intake and undersluice has been completed and plaster work at the hoist room of radial gate has been completed. Final lift concrete work at the stilling basin up to level 1370.00masl has been completed. About 97% excavation quantity of headworks has been completed. Epoxy cement mortar lining on the floor of stilling basin and undersluice section has been done on this month March. Excavation of Approach tunnel (230m) has been completed. Lining of intake tunnel for C type rock class at CH 0+194m to 0+208m and CH 0+147m to CH 0+158m has been completed. Lining of Inlet transition section from CH 0+9.52m to 0+21.52m has been completed. Concreting work at intake up to trash rack cleaning machine (TRCM) hoisting slab level 1395.00masl and hoisting slab of intake gate up to level 1397.00masl has been completed. Concrete work at the roof of hoist room up to level 1402.00masl has been completed. Second stage concrete work after installation of intake gate frame, trashrack frame and stoplog frames has been completed. Construction for the access road up to level 1390.50 of intake at the right bank of headworks has been completed, shotcrete work for the slope protection of rock at both side of headworks has been completed, frame of the door and windows installation at the control room has been completed, masonry wall for the access road area has been completed.

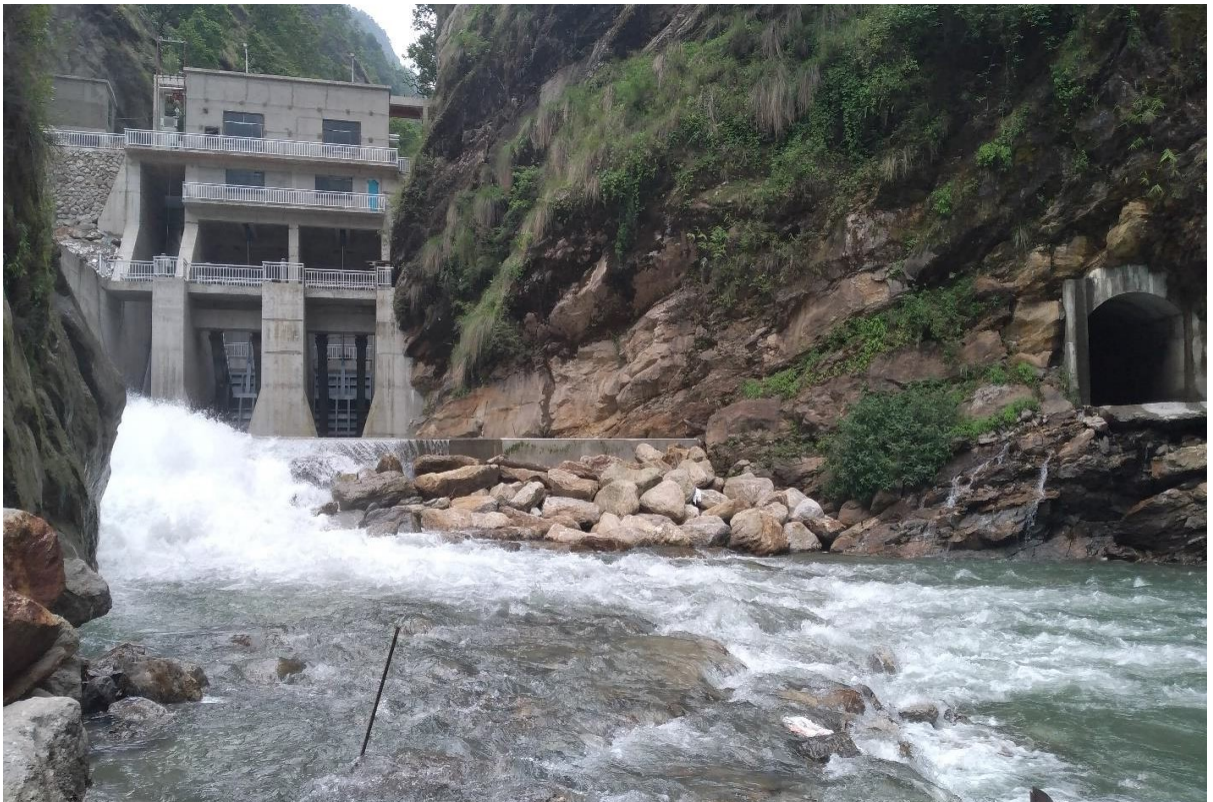
Figure 3: Downstream View of Headwork

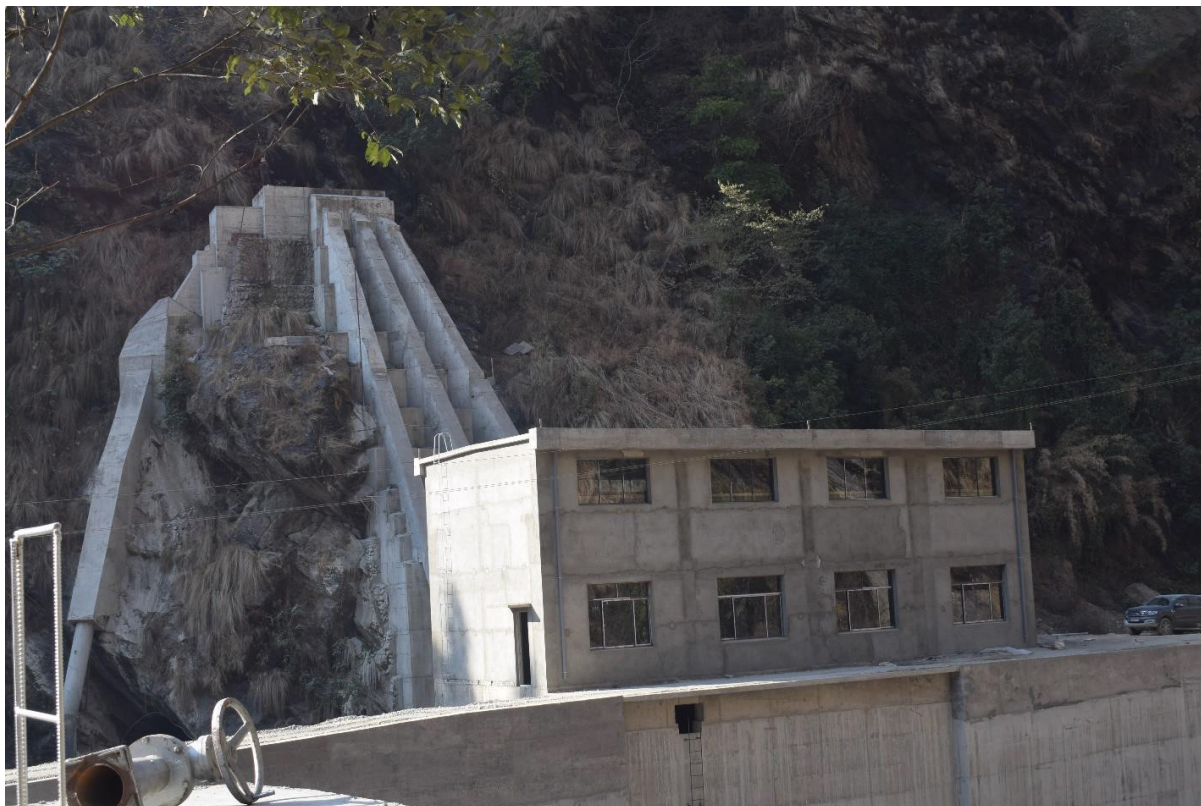
Figure 4: Pump House of Siuri Water Diversion System

Excavation of Siuri pumping outlet pool has been completed. Construction of outlet pool for storage of 1.1 m<sup>3</sup>/s discharge has been completed. Installation of three numbers of inlet pipe (40 cm diameter) and 70 cm diameter outlet pipe at the overhead tank has been completed. Construction of the retaining wall and pump house up to level 1379.00masl has been completed. Brickwork at the pump house has been completed, windows and door steel frame installation has been completed, glass installation at the windows has been completed, Plum concrete (C20) work for the retaining wall at the left Bank of Nyadi River near the Siuri diversion pump house has been completed. Inlet penstock pipe installation and construction of the weir has been completed on January 2021, plasterwork at the pump house has been completed. EOT and three pumps were installed in the month of January 2021.

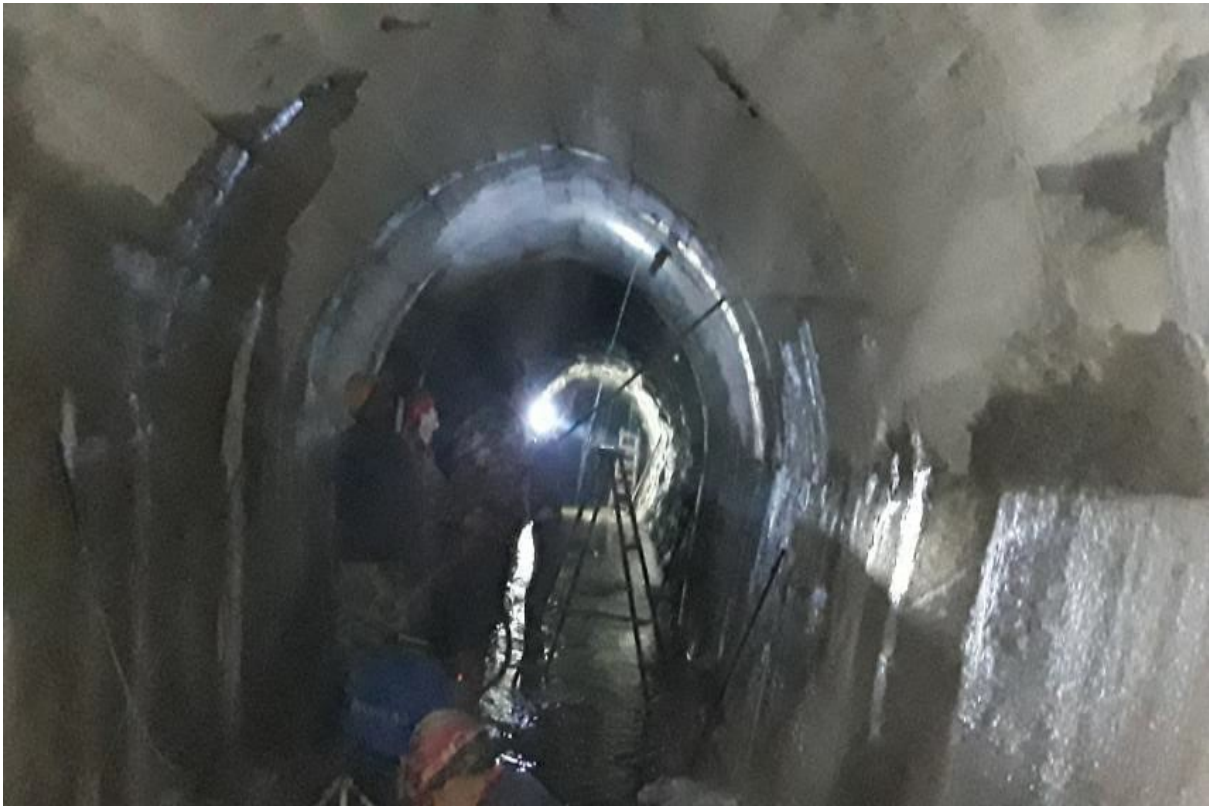
Figure 5: Grouting Work at Leakage Section of HRT Chainage 2+300m

over break has occurred at weak shear zone. Temporary supports have been provided to those over break portion. 11 Nos. of steel ribs, 7 Nos. of steel ribs and 6 Nos. of steel ribs have been provided to HRT from outlet at Ch.3+182 m to 3+192.6 m, 3+202 m to 3+210 m and 3+979.82 m to 3+984.82 m respectively. 6 nos. of steel ribs provided to Ch.0+1066-1071.10 m due to over break. HRT from access tunnel 2 towards Outlet has been excavated up to 480 m. At Ch.0+2330 large over break about 25-30 m occurred with debris flow, cleaning of the debris has been completed. 519 m HRT tunnel excavation was completed from Access tunnel I towards Access tunnel 2, over break from Ch. 0+886 m to Ch. 0+898 m has been provided with the support. C20 grade 75 mm thick invert lining up to Ch. 4+100 m has been completed. RCC lining from Ch 0+331m to 0+354 at downstream of Settling basin, from Ch 0+615m to 0+624m and from Ch 4+135.25 to 4+153.05 has been completed, from Ch 4+153.05 to 4+163.05 below spring level has been completed. Shotcrete at downstream of Adit 2 has been completed at various section of Rock class I section. Grouting work from Ch 0+615m to 0+624m, 0+899m to 0+909m and 1+064m to 1+071m has been completed. Rock bolt at various section according to requirement of rock class has been completed. Invert cleaning of HRT after the lining work has been completed. Concrete lining at the junction of Adit-I and Adit-2 for bulkhead gate installation has been completed. Flushing canal construction has been completed. Grouting works at the leakage section of HRT is ongoing.

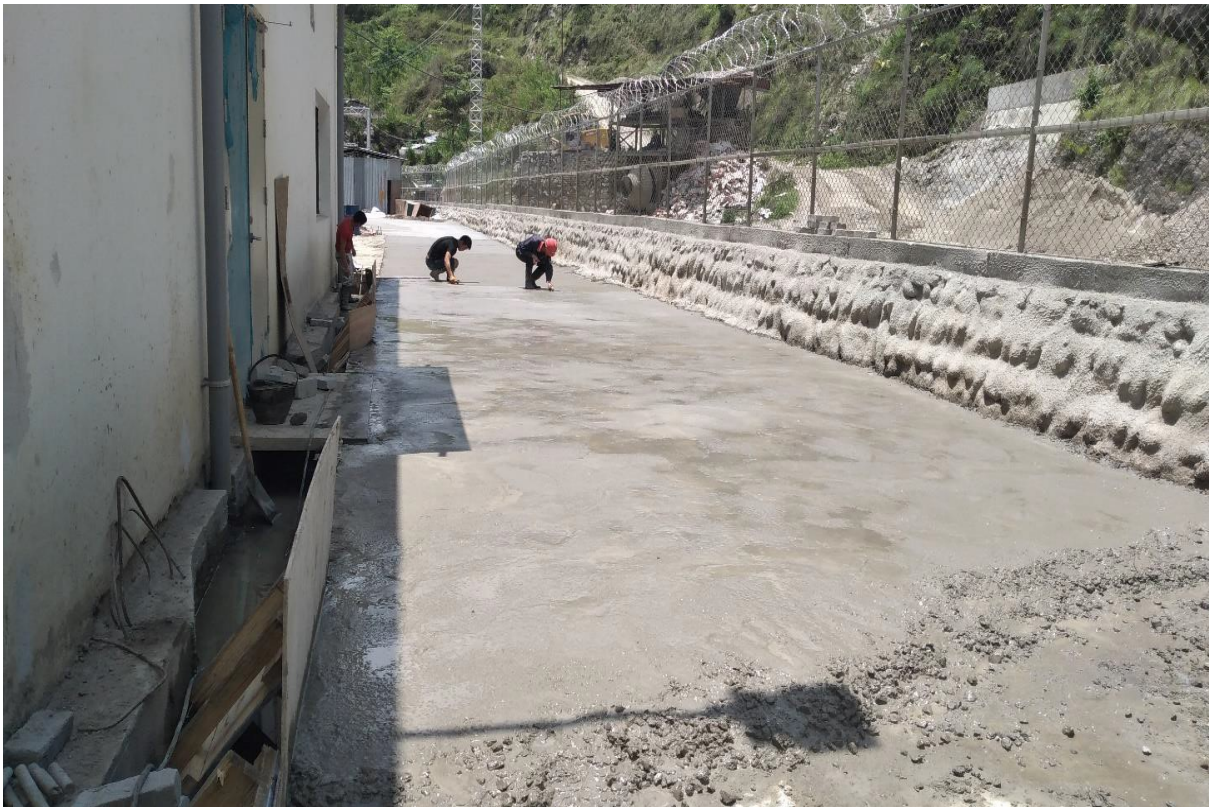
Figure 6: PCC Work at the Periphery of Powerhouse

Final level of powerhouse excavation is completed and the structural concreting has been completed. About 97% of Civil work has been completed till the month of March 2021. Concreting work at slab of Assembly bay level 1047.00 m has been completed. Structural concreting of beam and column up to roof level at Assembly bay 1066.715 m and at Control room up to level 1058.345 m has been completed. Roofing of powerhouse has been completed. Brick work for housing construction has been completed. Plaster work at outside and inner side of powerhouse has been completed. Painting work has been completed. Steel Doors and windows frames installation has been completed. Glass installation on windows has been completed. Railing installation at staircase and cut out portion has been completed. Drainage at the periphery of powerhouse building has been completed. Plaster work at floor of main unit, control room and auxiliary powerhouse has been completed. Laying of tile on the floor of control room, main unit section has been started on the month June 2020 and the work is ongoing. Parqueting work and false ceiling work at the control room section of power house has been started from the month of July 2020. Temporary camp dismantles and surface leveling at powerhouse area has been completed. Structural concrete of tailrace has been completed. River protection works has been completed in the powerhouse area. Retaining wall about 153m has been completed. Stone soling work at the slope of retaining wall of powerhouse about 153m has been completed. Construction of the boundary wall and fencing work at the boundary on the periphery of the powerhouse and switchyard area is started in the month of September 2020 and the work is ongoing.

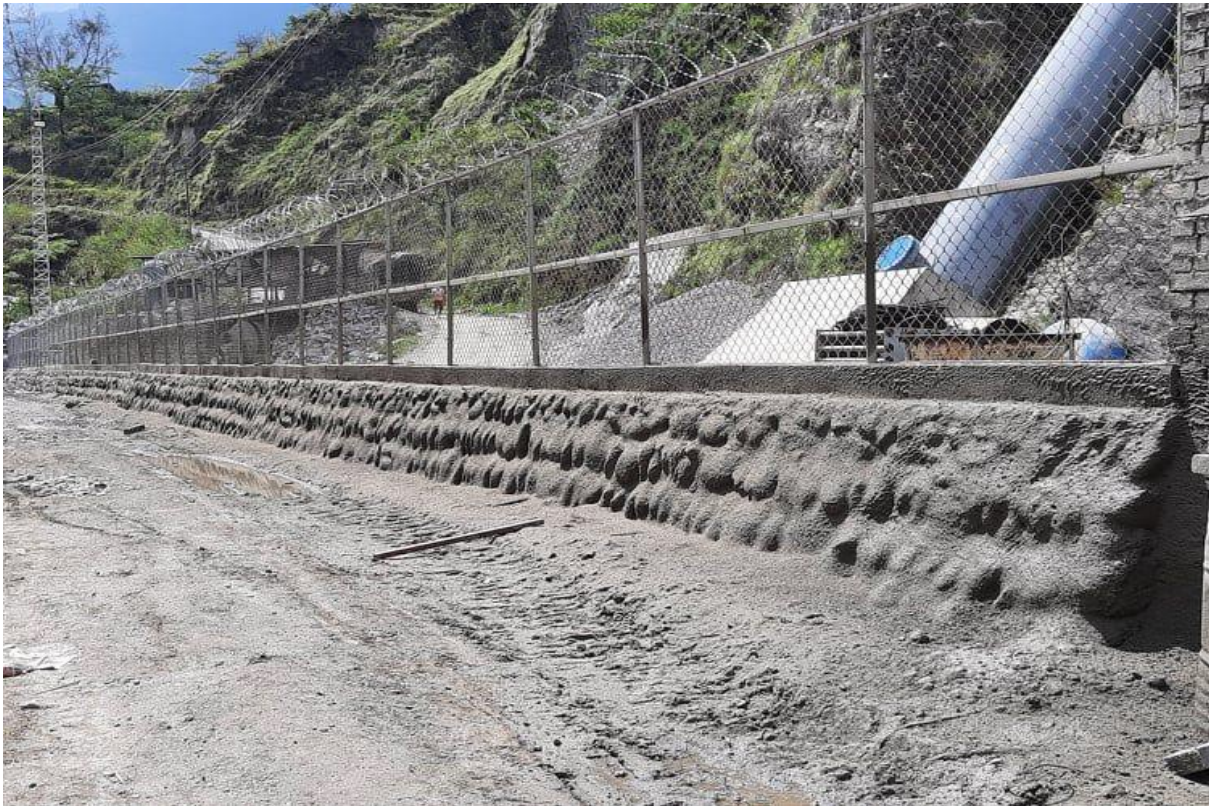
Figure 7: Shotcrete Work on the Boundary Wall of Powerhouse

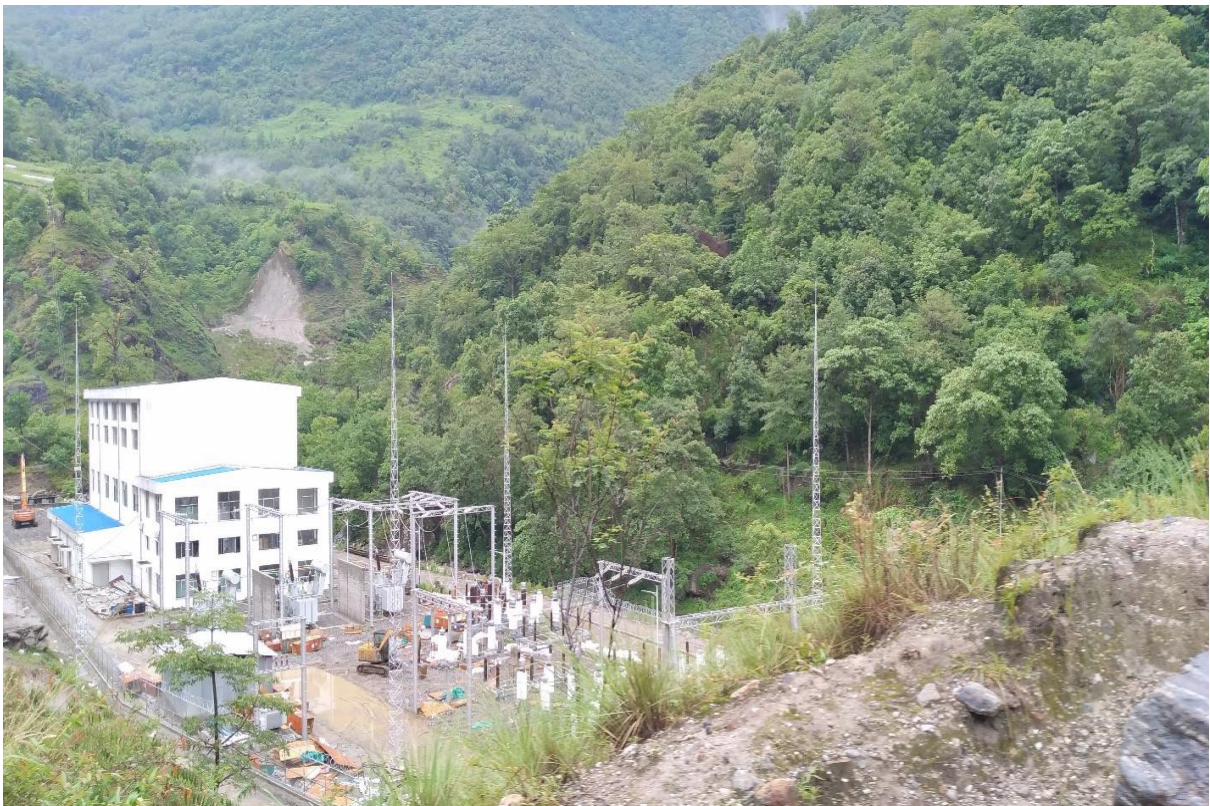
Figure 8: Outlook of Powerhouse and Switchyard Area

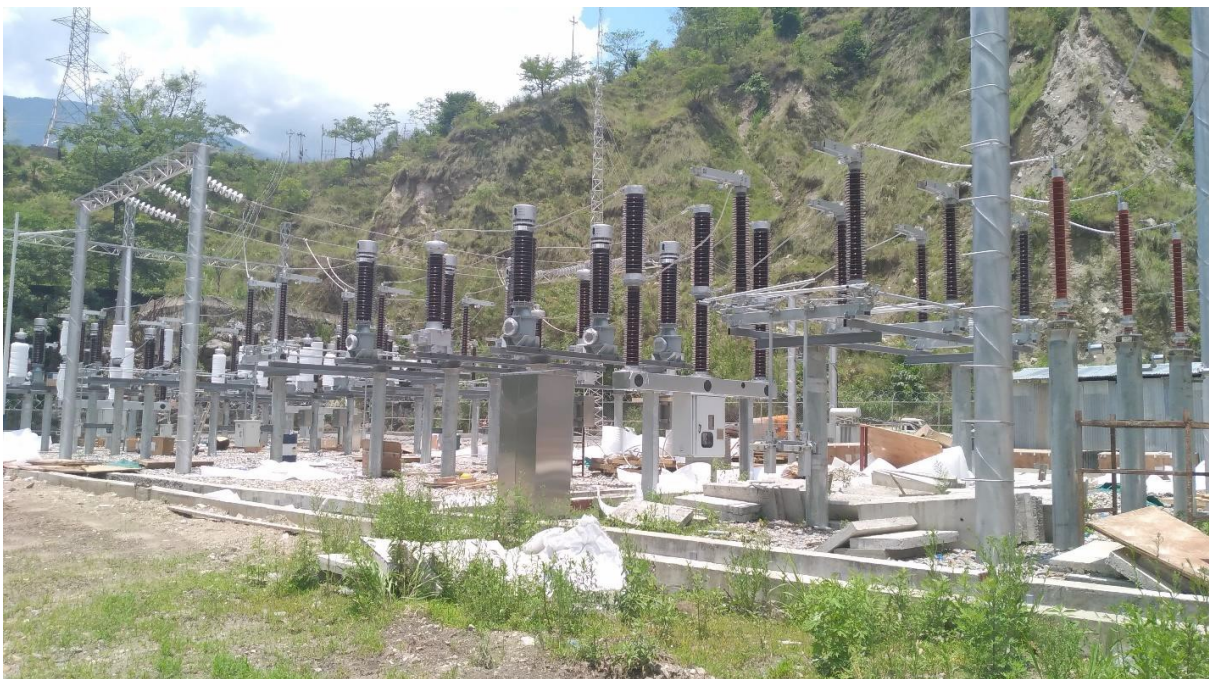
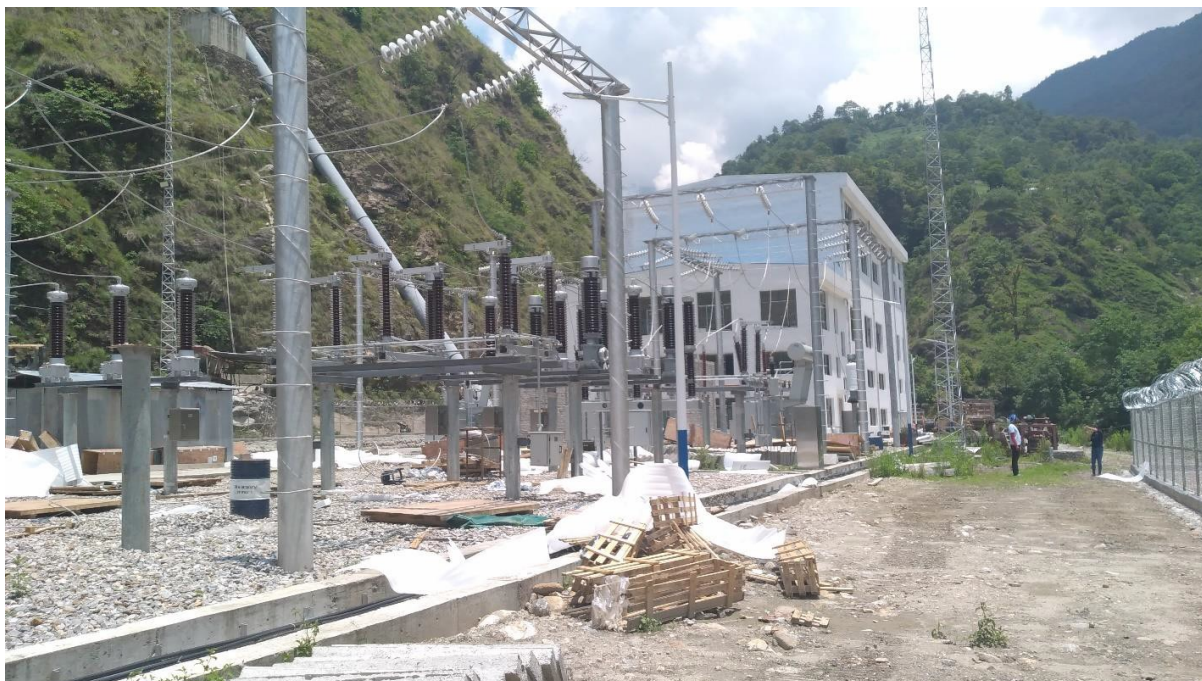
Figure 9: CT/PT Installation at Switchyard

Figure 10: CT/PT Installation at Switchyard

Switch gear equipment has been completely installed in the month of May 2021, mean while internal wiring connection will be continued for upcoming two months.

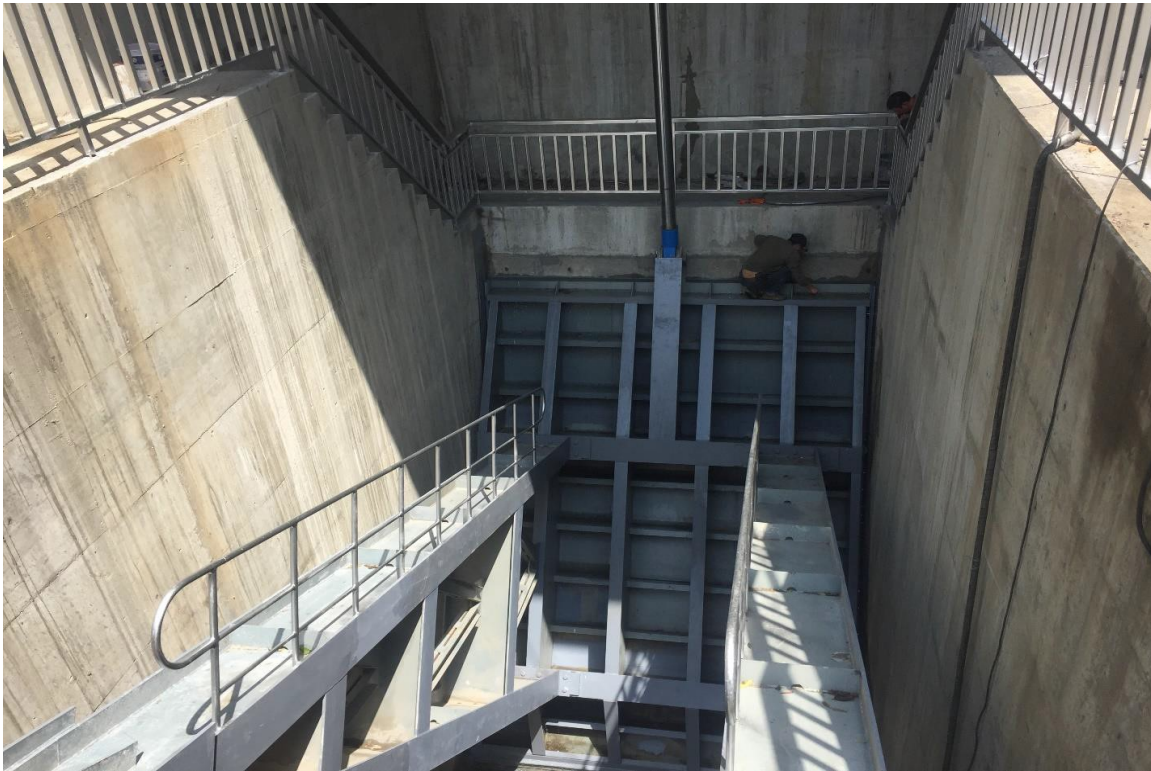
Figure 11: Top Seal Being Tighten of Radial Gates

This month, hydro mechanical work was fully focused on Radial gates. Photographs below include both of the sections under installation.

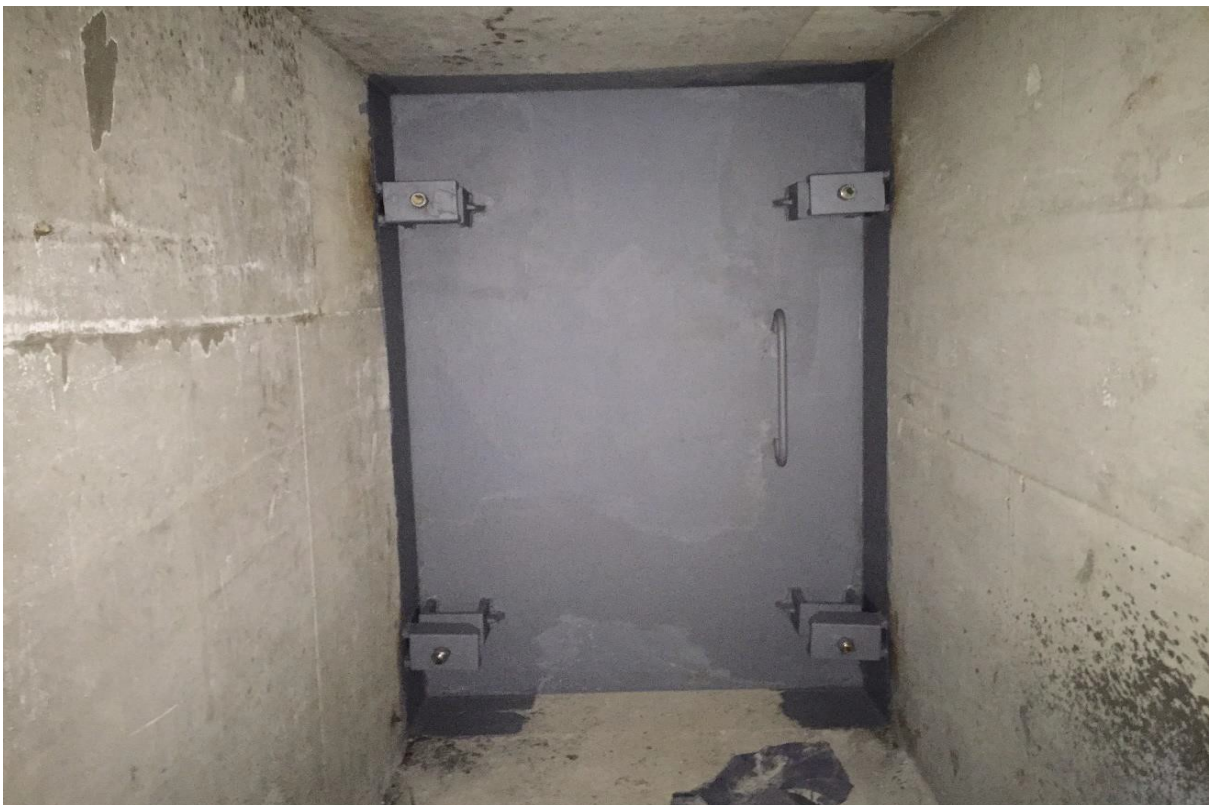
Figure 12: Bulkhead Gate of Adit 2

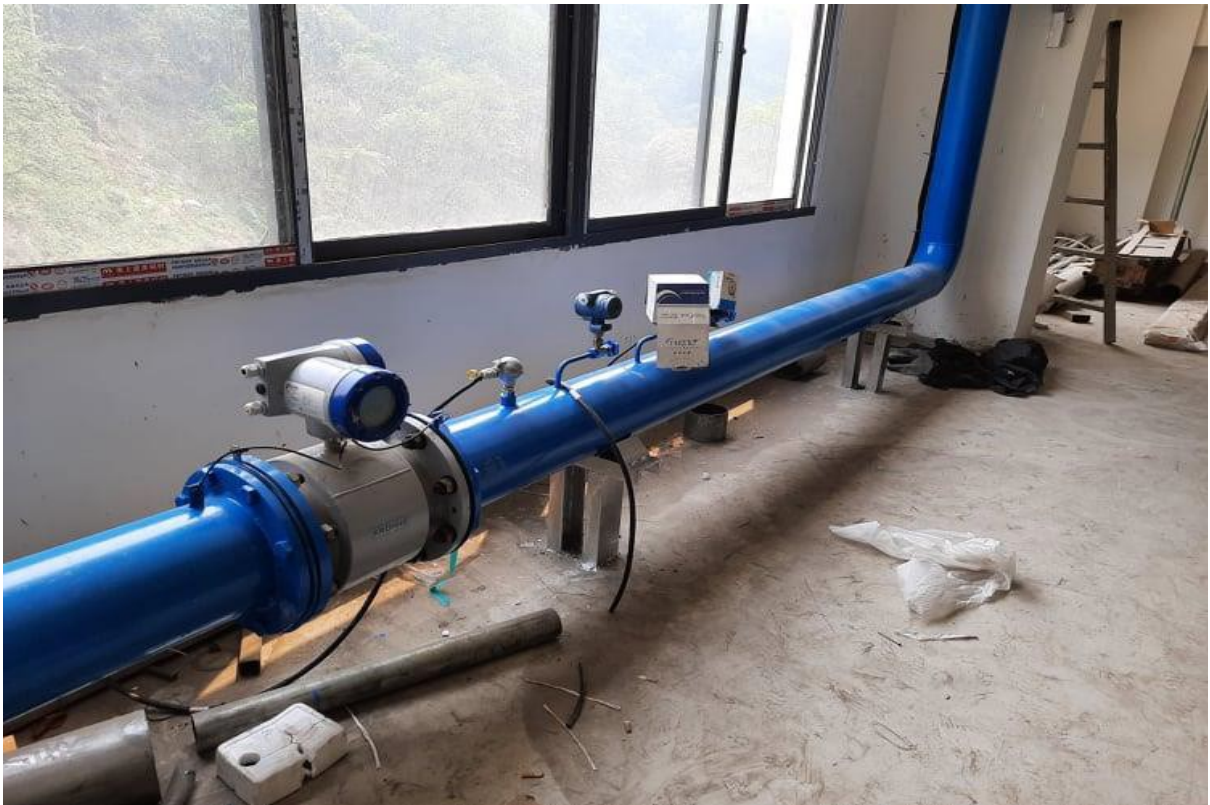
Figure 13: Cable Connection in Water Flow Meter and Micro Sensor of Water-cooling System

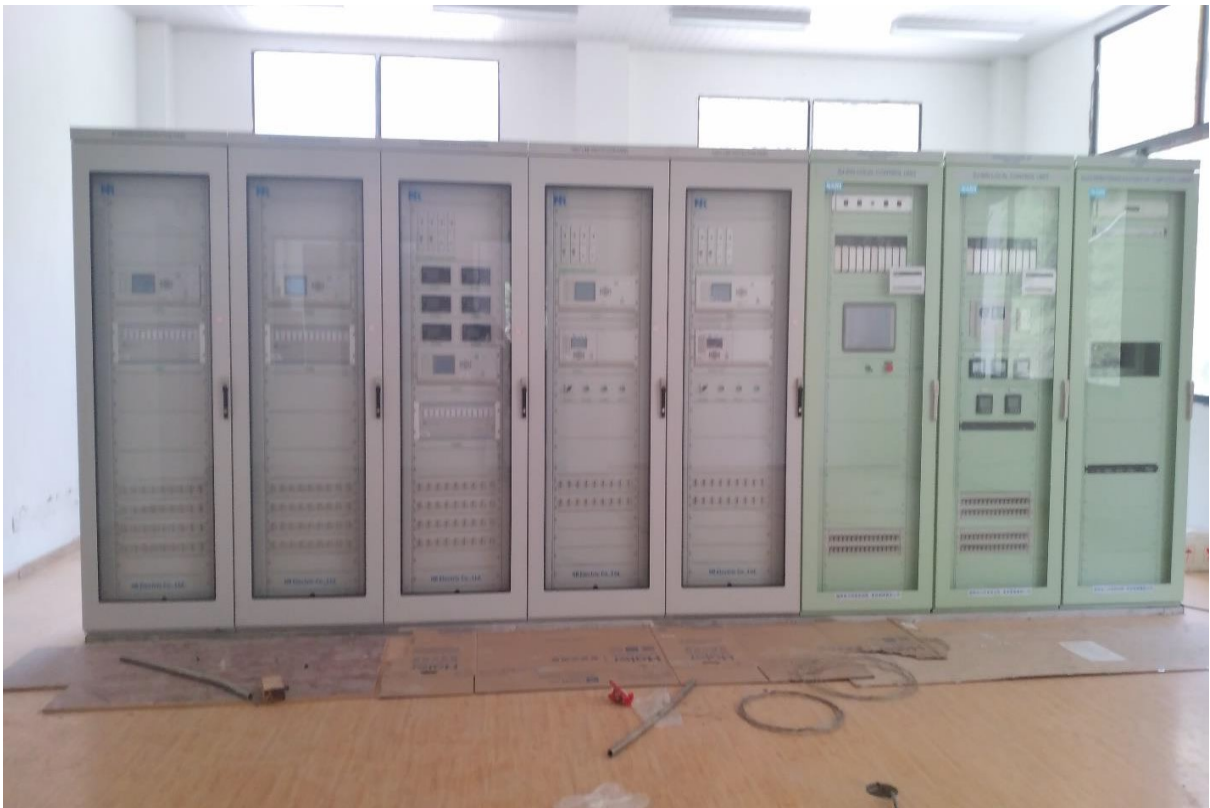
Figure 14: Protection System

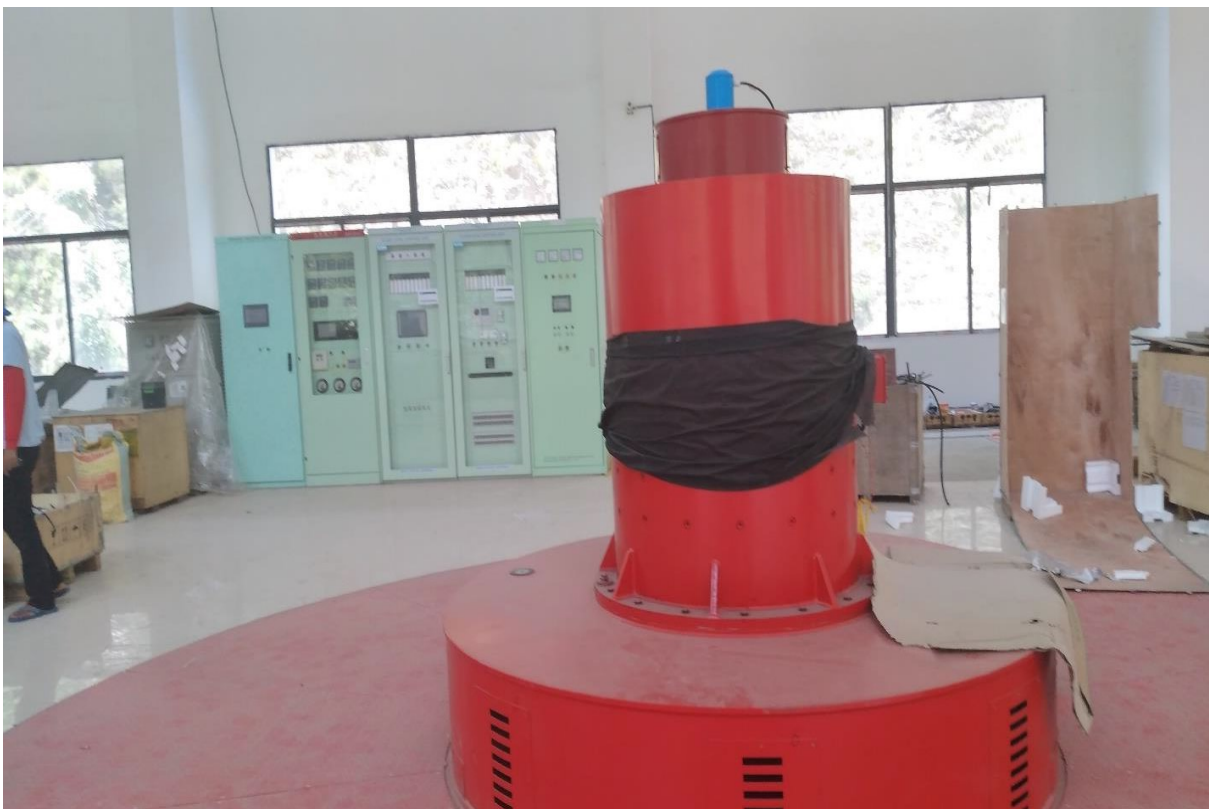
Figure 15: Generator Room

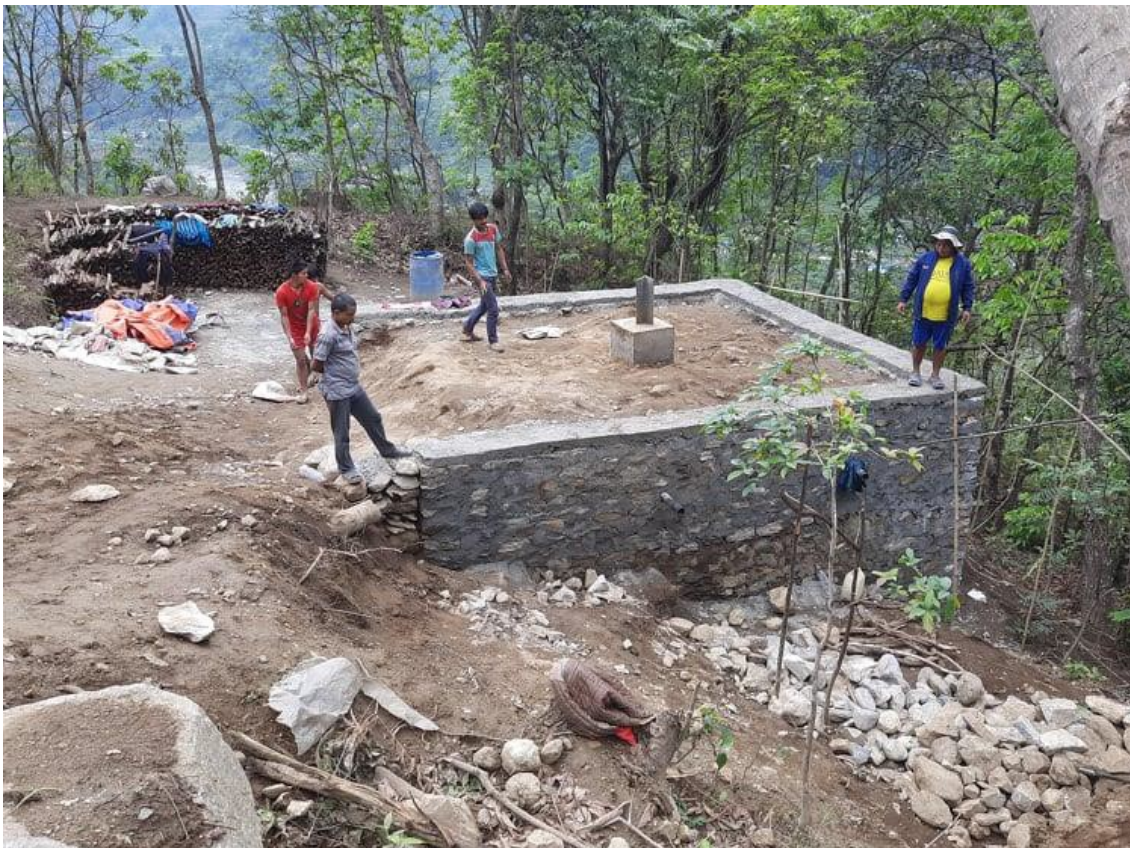
Figure 16: Foundation Protection Works at Transmission Line Tower no. 24

Foundation protection works for Towers 2, 3, 4, 12, 13, 15, 16, 18, 21, 22 and 23 completed.

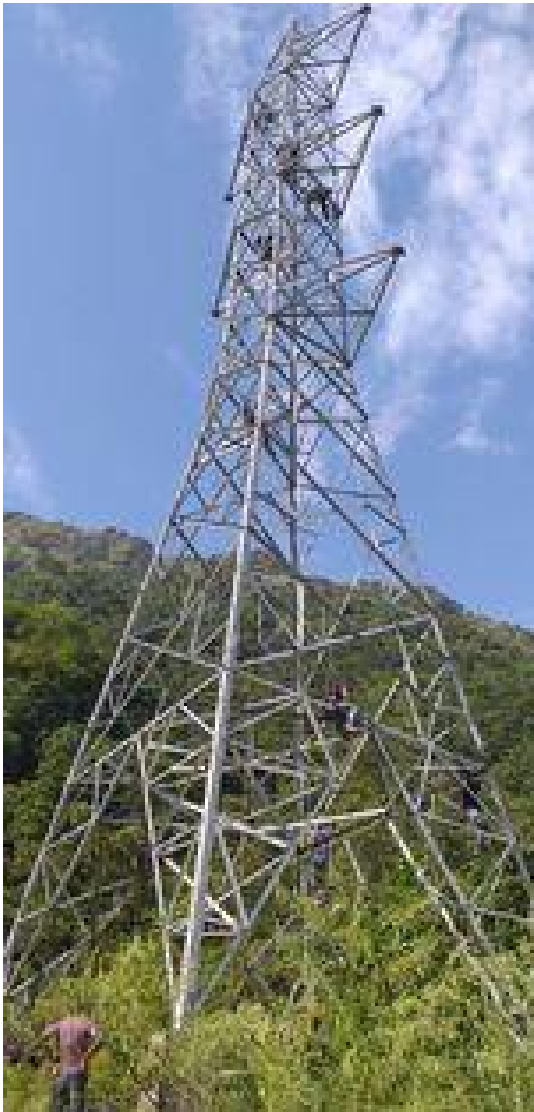
Figure 17: Installation of Transmission Line Tower No. 19

Tower erection has been started on the month of October 2020. Erection of Towers T2, T3, T4, T5, T6, T7, T8, T9, T10, T11, T12, T13, T14, T15, T16, T17, T18, T19, T20, T23 and T24 has been completely erected till this month.
