Nyadi Hydropower Project (30 MW)

Progress Report

(April 2021)

Monthly Progress Report

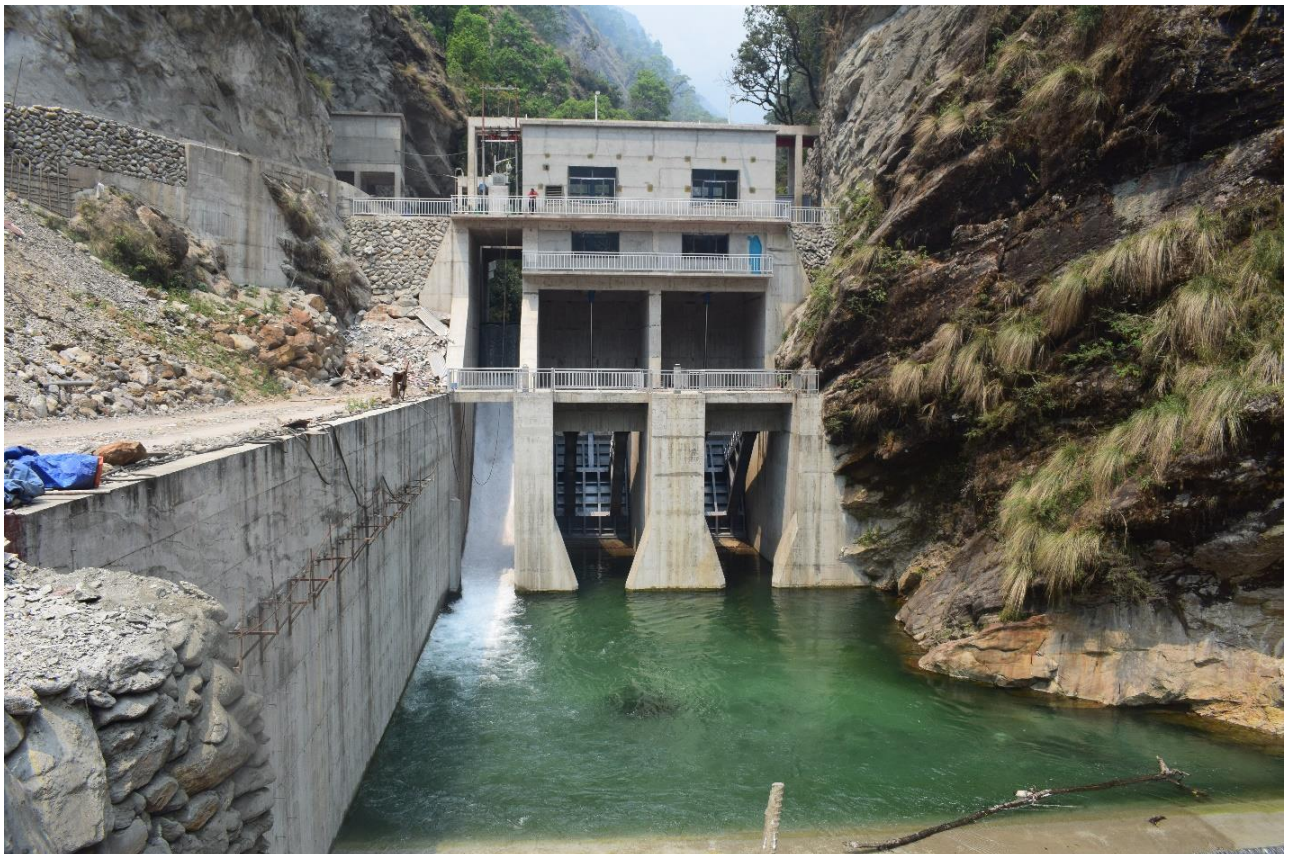
Figure 5: Outlook of Headworks

Excavation and concreting of first cut-off wall up to level 1372.00 m at dam site have been completed. Concreting of second cut-off wall and downstream cut-off wall up to level 1372.00 m have been completed.

Likewise, a submerged sand trap at upstream of first cut-off wall up to level 1374.00 m and intermediate submerged sand trap wall up to 1381.00 m has been completed. Retaining wall of stilling basin at right bank of river up to level 1381.00 m has been completed. Curtain grouting work at first cut-off wall has also been completed. Grouting at both side of dam axis between first and second cut off wall has been completed. Concreting up to level 1398.00m at stop logs and radial gates section of Dam has been completed. Brick work at the control room and hoist room of intake and undersluice has been completed and plaster work at the hoist room of radial gate has been completed. Final lift concrete work at the stilling basin up to level 1370.00masl has been completed. About 97% excavation quantity of headworks has been completed. Epoxy cement mortar lining on the floor of stilling basin and undersluice section has been done on this month March. Excavation of Approach tunnel (230m) has been completed. Lining of intake tunnel for C type rock class at CH 0+194m to 0+208m and CH 0+147m to CH 0+158m has been completed. Lining of Inlet transition section from CH 0+9.52m to 0+21.52m has been completed. Concreting work at intake up to trash rack cleaning machine (TRCM) hoisting slab level 1395.00masl and hoisting slab of intake gate up to level 1397.00masl has been completed. Concrete work at the roof of hoist room up to level 1402.00masl has been completed. Second stage concrete work after installation of intake gate frame, trashrack frame and stoplog frames has been completed. Construction for the access road up to level 1390.50 of intake at the right bank of headworks has been completed, shotcrete work for the slope protection of rock at both side of headworks has been completed, frame of the door and windows installation at the control room has been completed, masonry wall for the access road area has been completed.

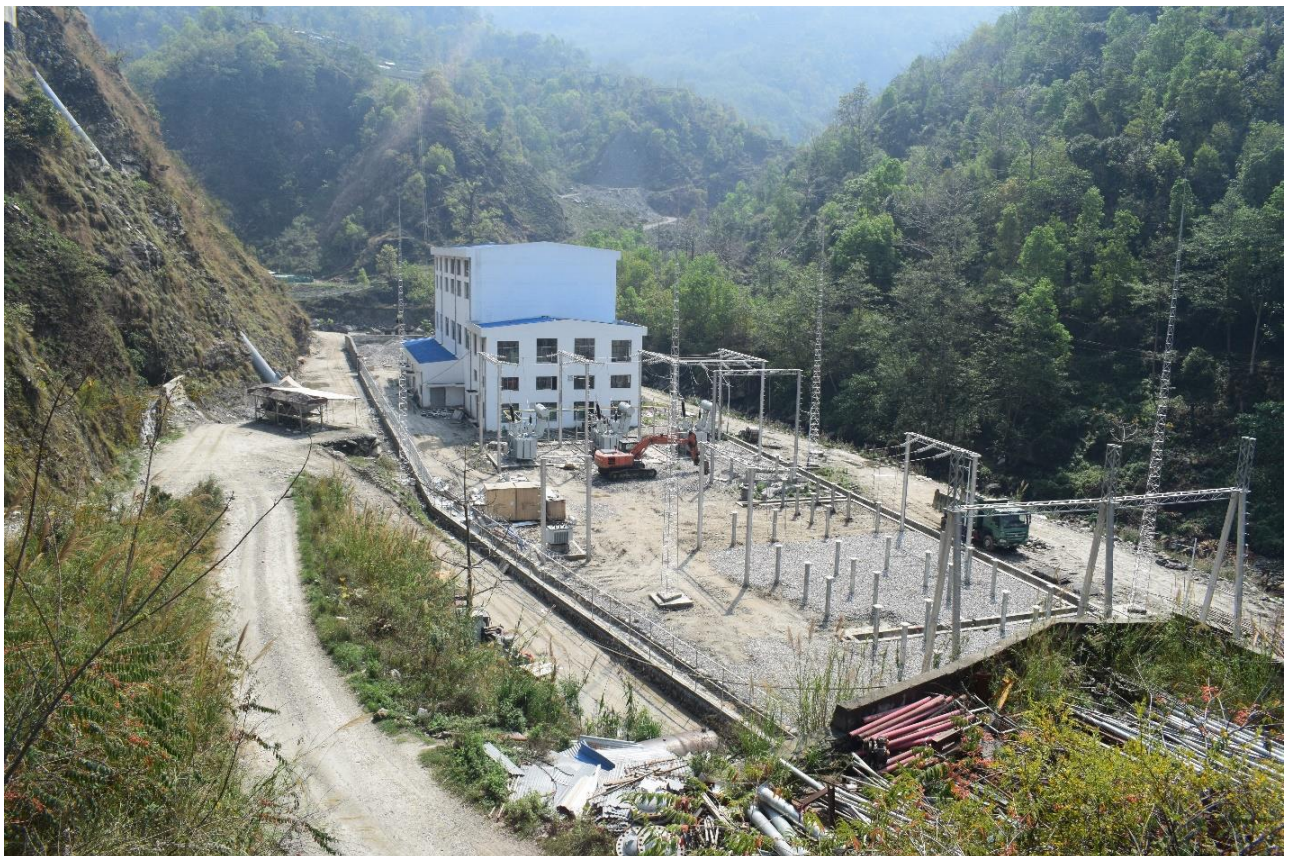
Figure 8: Outlook of Powerhouse and Switchyard Area

Final level of powerhouse excavation is completed and the structural concreting has been completed. About 97% of Civil work has been completed till the month of March 2021. Concreting work at slab of Assembly bay level 1047.00 m has been completed. Structural concreting of beam and column up to roof level at Assembly bay 1066.715 m and at Control room up to level 1058.345 m has been completed. Roofing of powerhouse has been completed. Brick work for housing construction has been completed. Plaster work at outside and inner side of powerhouse has been completed. Painting work has been

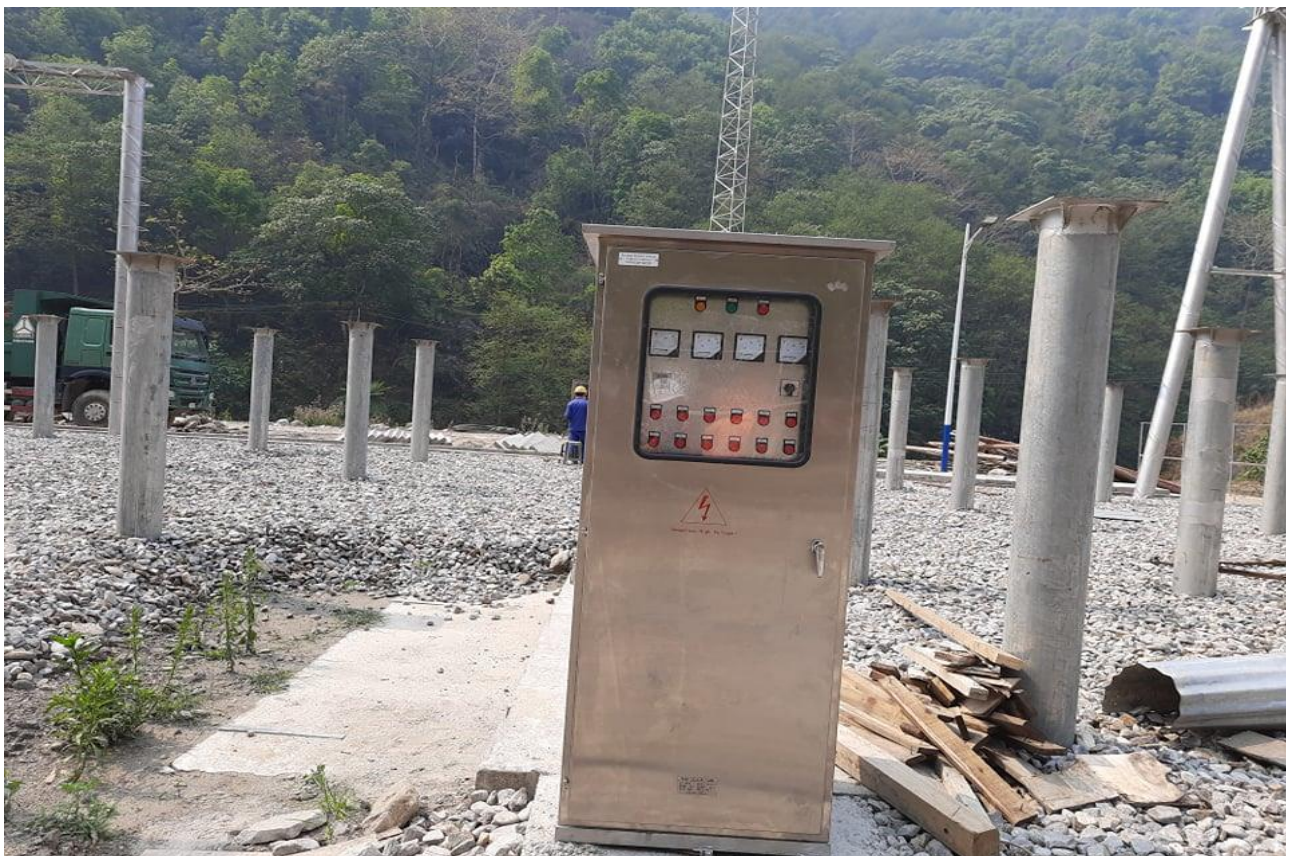
Figure 11: Power Cabinet Installation at Switchyard

Cabling of booster station and the distribution transformer was progressed on the month of April 2021.

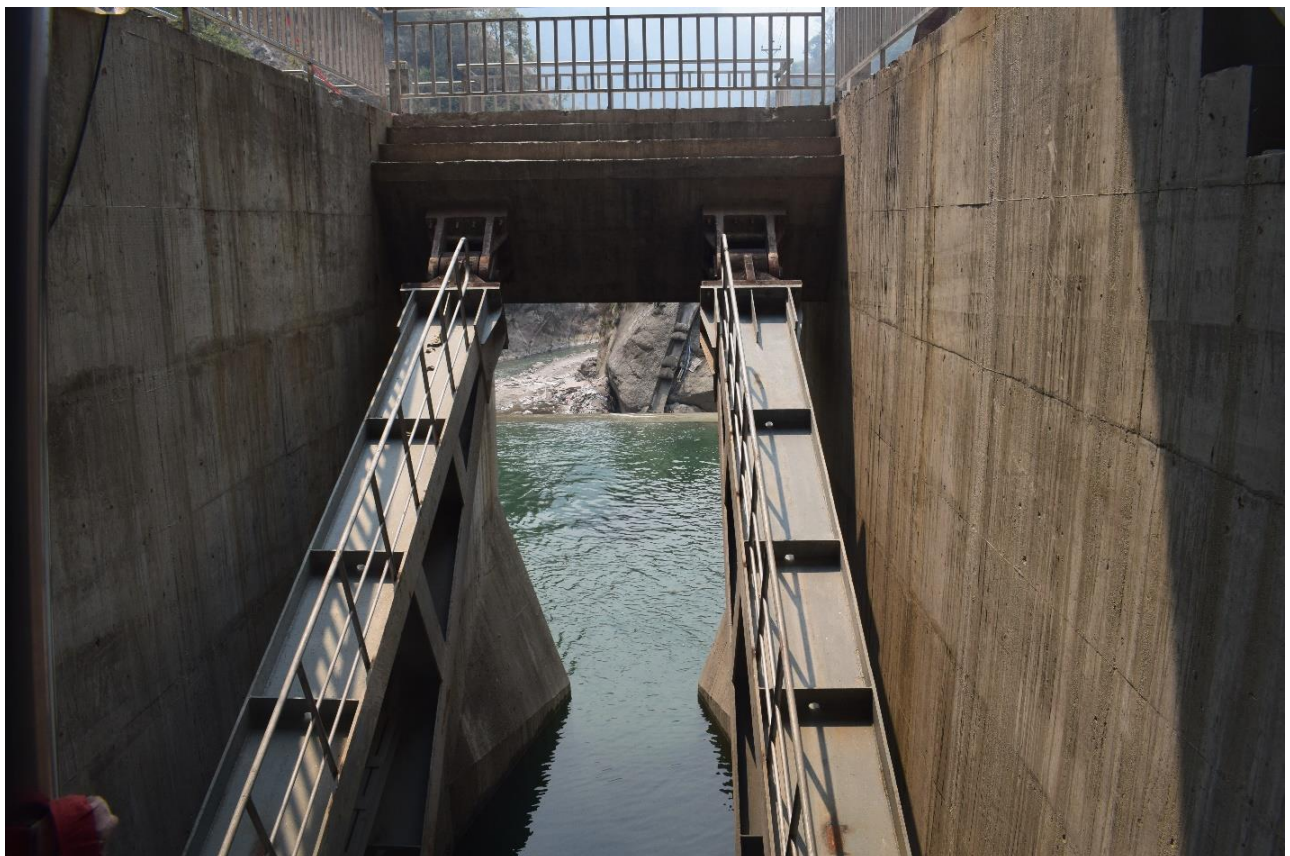
Figure 12: Hinge of Radial Gates

This month, hydro mechanical work was fully focused on Radial gates. Photographs below include both of the sections under installation.

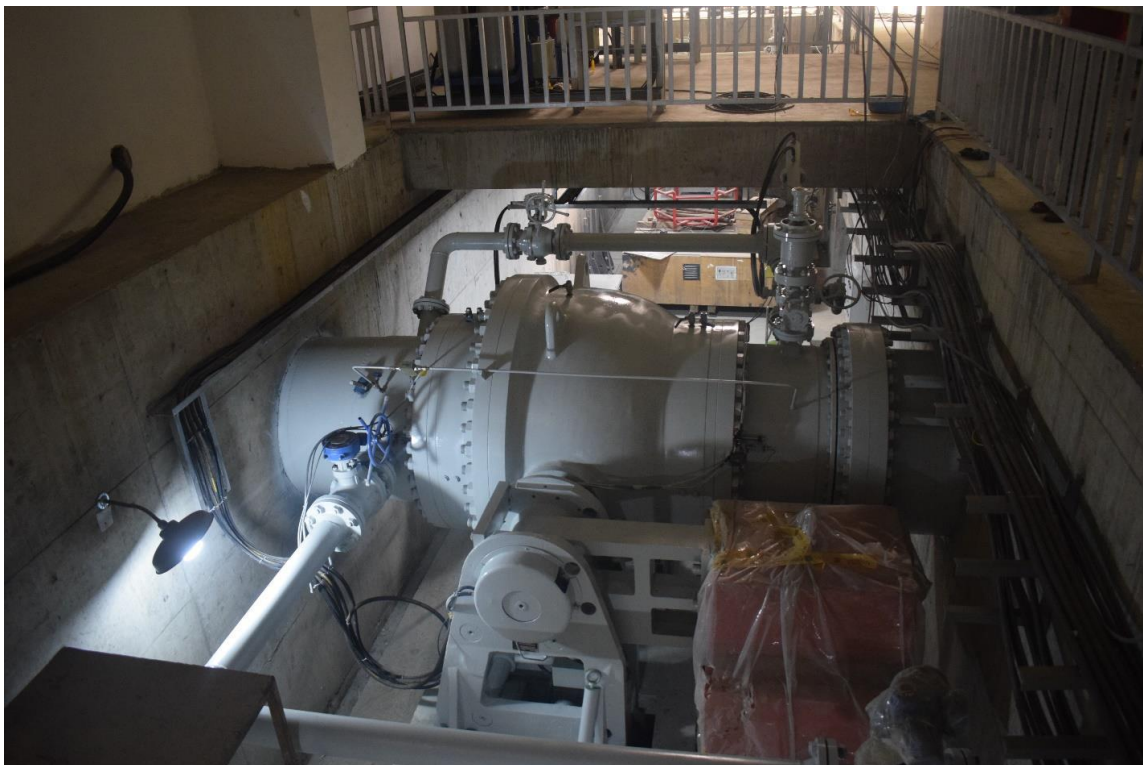
Figure 14: Painting Work at the MIV

Both units of Main Spherical valve have been completely installed mechanically on the month of July. For this purpose, proper alignment and leveling as per the EPC was obtained, meanwhile the various components of the Unit i.e. air valve, hydraulic needle valve, main hole, upstream and downstream expansion joints were installed with the help of adequate size of nuts bolts as recommended by the manufacturer. Furthermore, control cabinet and other electrical control system is yet to be installed in further months ahead. This was properly earthed. Furthermore, the heavy hammer, brake interface, by pass system, overhaul ball valve was completely assembled for both of the Units. Anti-nozzle pipe was connected for Unit#2 on the month of November 2020.

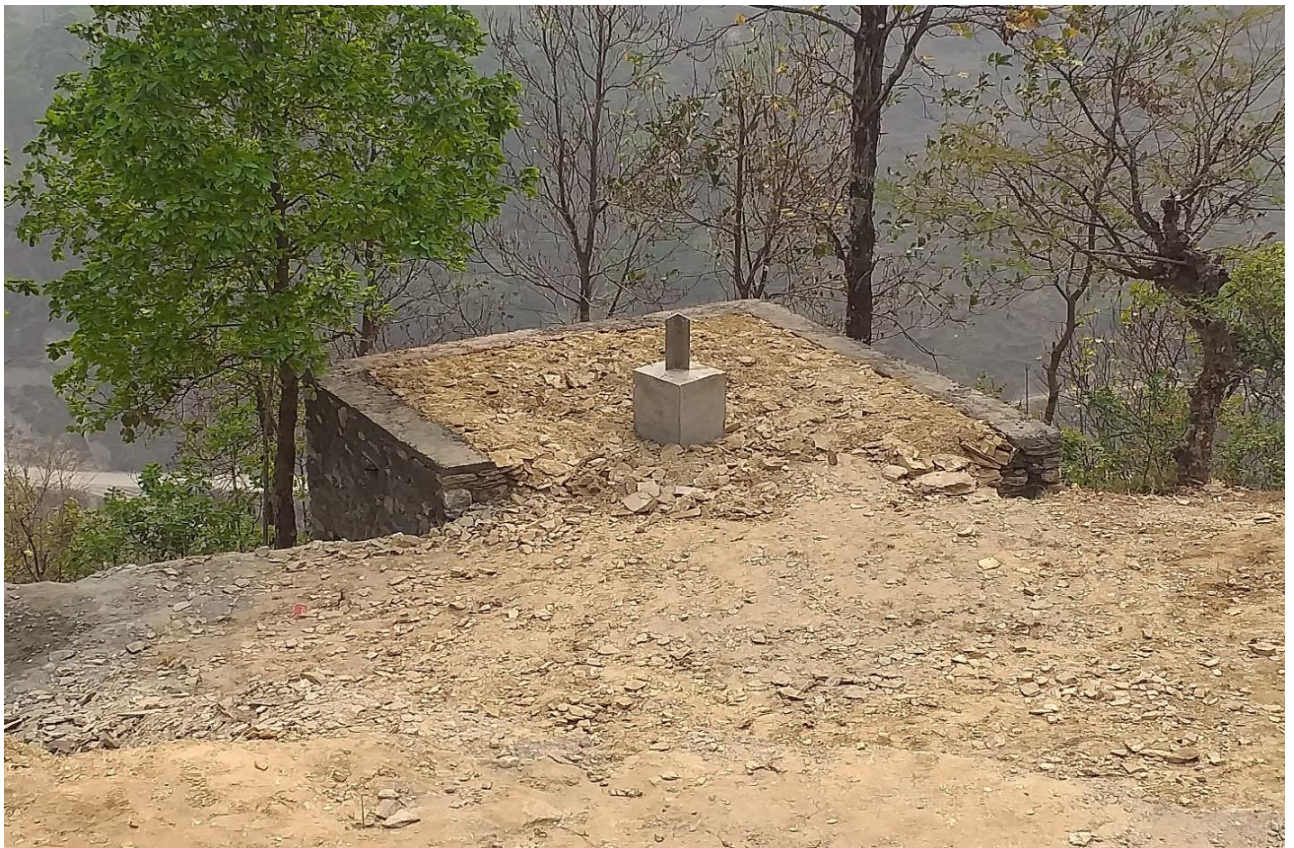
Figure 18: Foundation Protection Works at Transmission Line Tower no. 22

Foundation protection works for Towers 2, 3, 4, 12, 13, 15, 16, 18, 21, 22 and 23 completed.

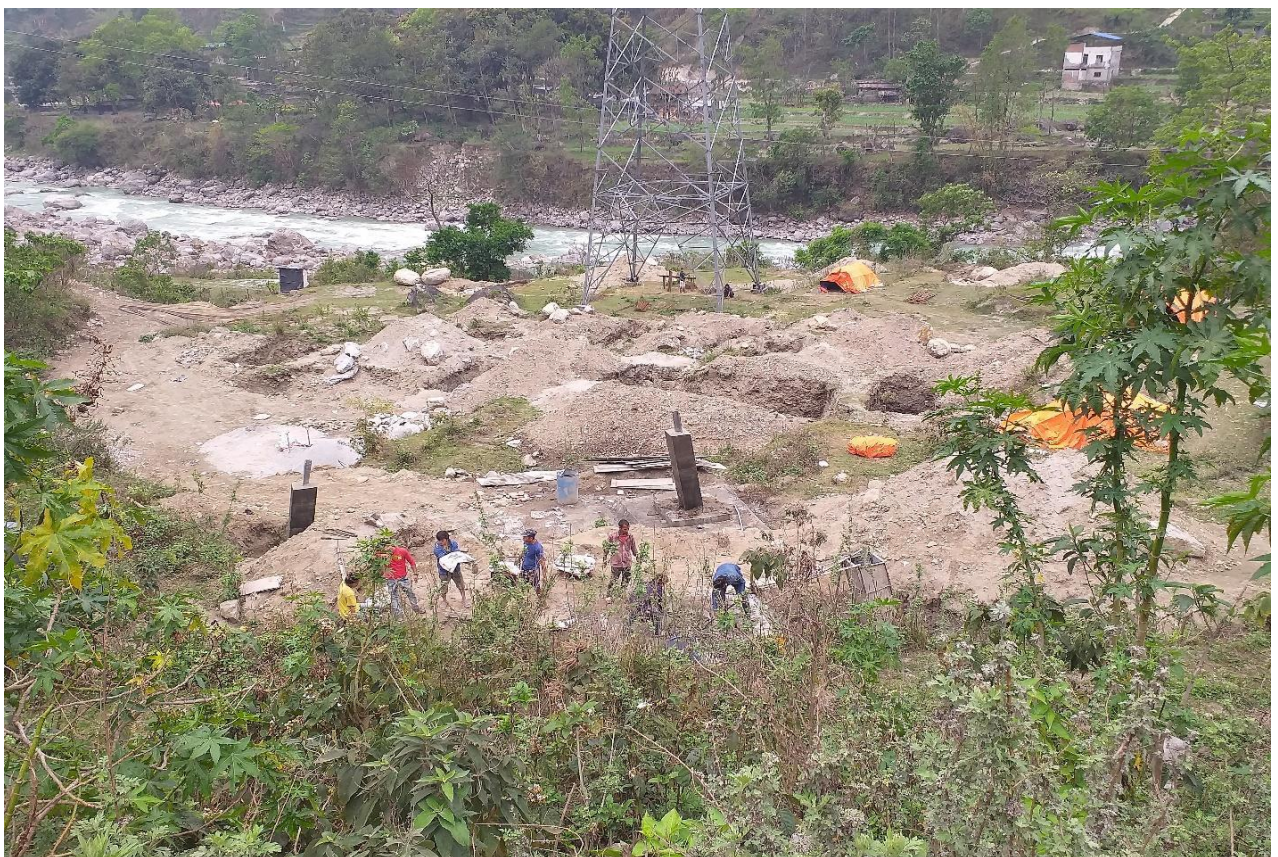
Figure 19: Concrete Work at the Transmission Line Tower No. 25

For the month of April 2021, the foundation work for tower no. 2, 3, 4, 5, 6, 7, 8, 9, 10, 11, 12, 13, 14, 15, 16, 17, 18, 19, 20, 21, 22, 23, 24 and 25 of 132kV Transmission Line has been completed.
