## **Nyadi Hydropower Project (30 MW)**

### **Progress Report**

(September 2021)

Monthly Progress Report

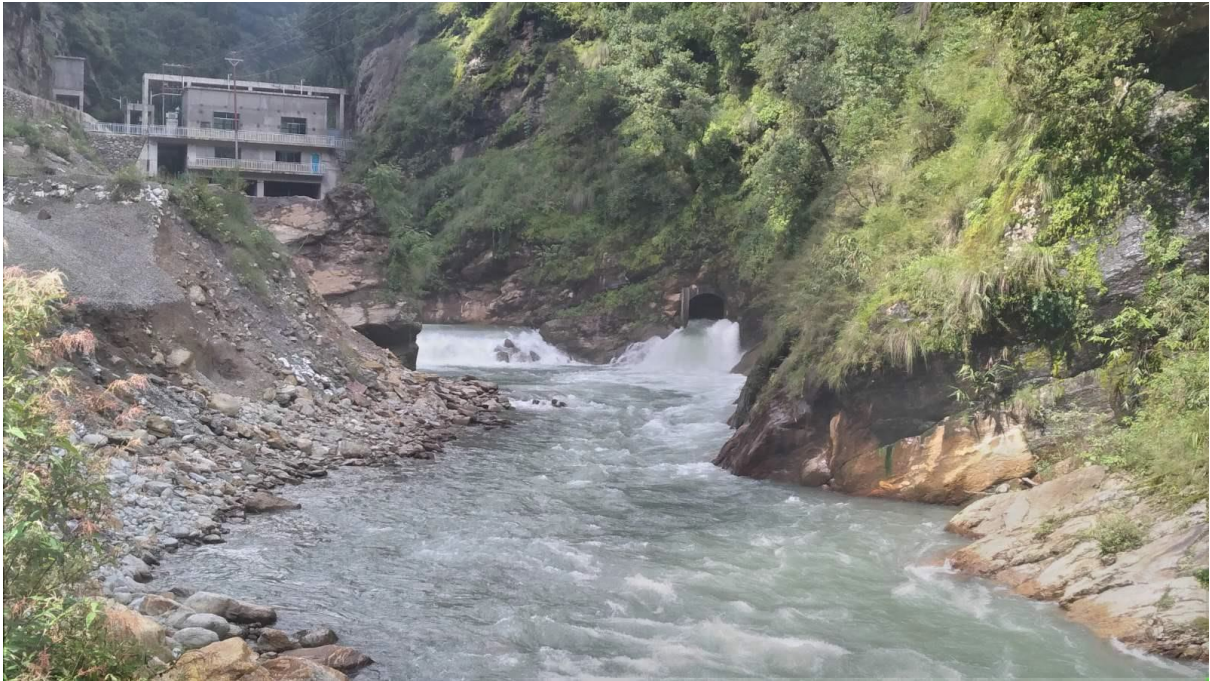
Figure 2: Outlet of Diversion Tunnel

The 300 m long diversion tunnel excavation has been finished. Concreting at Inlet and outlet part has been completed.

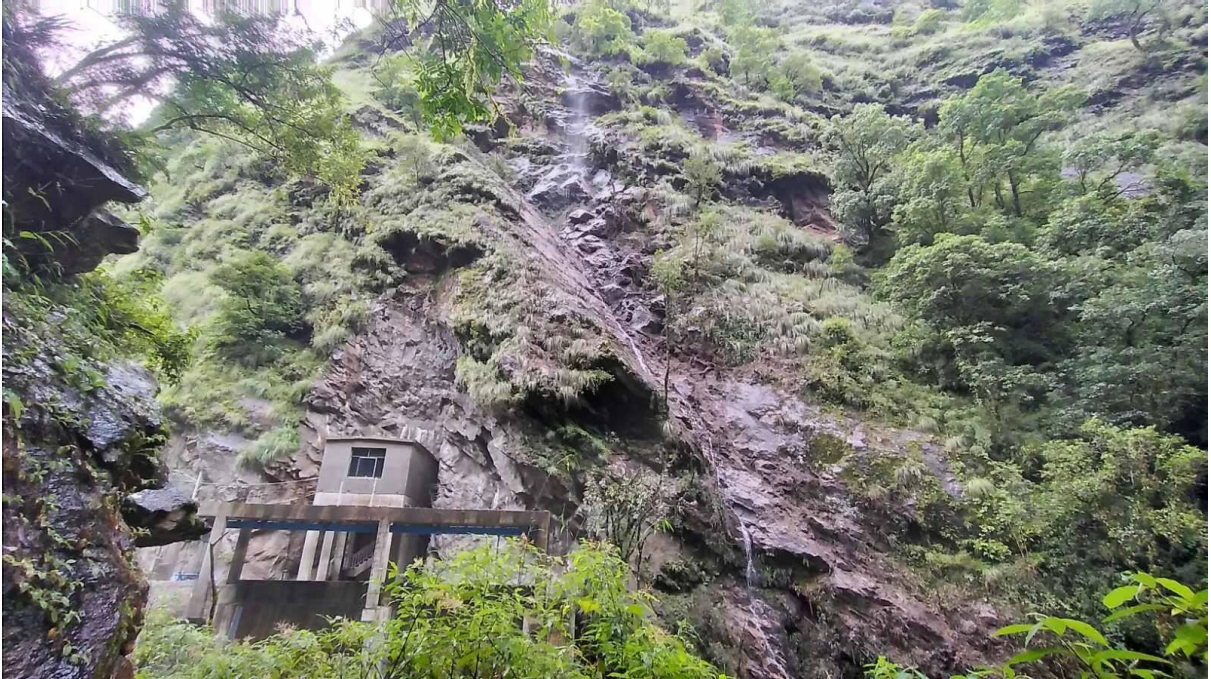
Figure 3: Intake Side View of Headworks

Excavation and concreting of first cut-off wall up to level 1372.00 m at dam site have been completed. Concreting of second cut-off wall and downstream cut-off wall up to level 1372.00 m have been completed. Likewise, a submerged sand trap at upstream of first cut-off wall up to level 1374.00 m and intermediate submerged sand trap wall up to 1381.00 m has been completed. Retaining wall of stilling basin at right bank of river up to level 1381.00 m has been completed. Curtain grouting work at first cut-off wall has also been completed. Grouting at both side of dam axis between first and second cut off wall has been completed. Concreting up to level 1398.00m at stop logs and radial gates section of Dam has been completed. Brick work at the control room and hoist room of intake and undersluice has been completed and plaster work at the hoist room of radial gate has been completed. Final lift concrete work at the stilling basin up to level 1370.00masl has been completed. About 97% excavation quantity of headworks has been completed. Epoxy cement mortar lining on the floor of stilling basin and undersluice section has been done on this month March 2021. Excavation of Approach tunnel (230m) has been completed. Lining of intake tunnel for C type rock class at CH 0+194m to 0+208m and CH 0+147m to CH 0+158m has been completed. Lining of Inlet transition section from CH 0+9.52m to 0+21.52m has been completed. Concreting work at intake up to trash rack cleaning machine (TRCM) hoisting slab level 1395.00masl and hoisting slab of intake gate up to level 1397.00masl has been completed. Concrete work at the roof of hoist room up to level 1402.00masl has been completed. Second stage concrete work after installation of intake gate frame,

trashrack frame and stoplog frames has been completed. Construction for the access road up to level 1390.50 of intake at the right bank of headworks has been completed, shotcrete work for the slope protection of rock at both side of headworks has been completed, frame of the door and windows installation at the control room has been completed, masonry wall for the access road area has been completed.

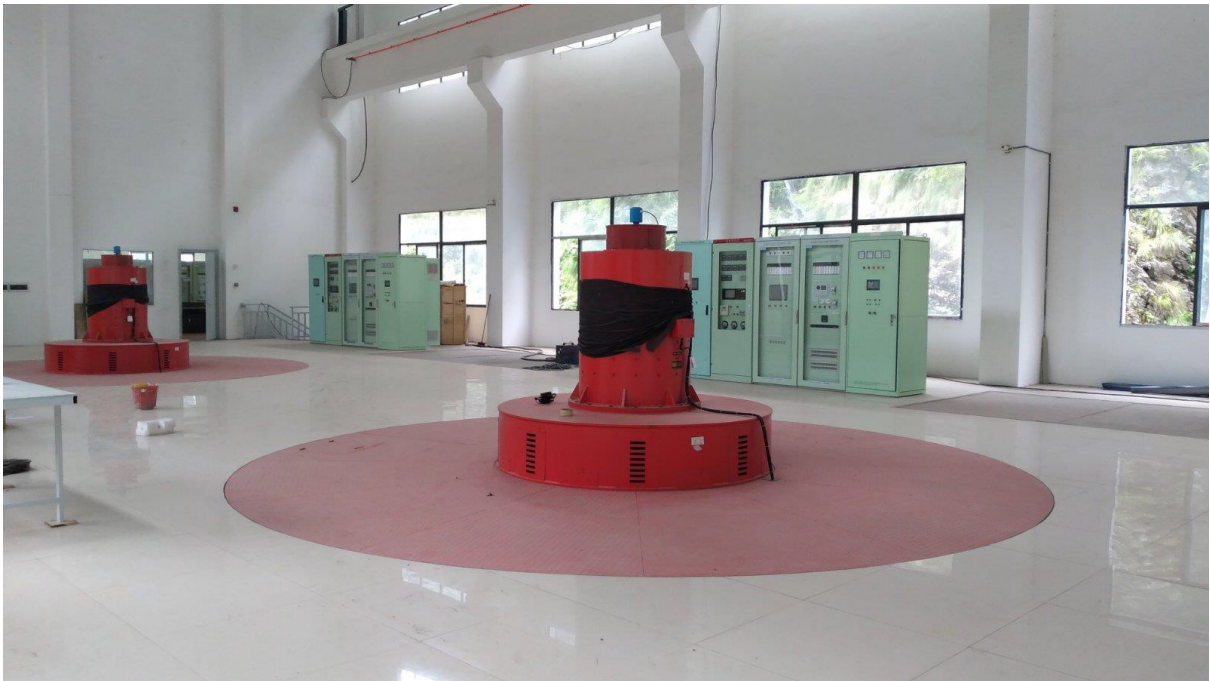
Figure 5: Machine Hall of the Powerhouse

Final level of powerhouse excavation is completed and the structural concreting has been completed. About 97% of Civil work has been completed till the month of June 2021. Concreting work at slab of Assembly bay level 1047.00 m has been completed. Structural concreting of beam and column up to roof level at Assembly bay 1066.715 m and at Control room up to level 1058.345 m has been completed. Roofing of powerhouse has been completed. Brick work for housing construction has been completed. Plaster work at outside and inner side of powerhouse has been completed. Painting work has been

completed. Steel Doors and windows frames installation has been completed. Glass installation on windows has been completed. Railing installation at staircase and cut out portion has been completed. Drainage at the periphery of powerhouse building has been completed. Plaster work at floor of main unit, control room and auxiliary powerhouse has been completed. Laying of tile on the floor of control room, main unit section has been started on the month June 2020 and the work is ongoing. Parqueting work and false ceiling work at the control room section of power house has been started from the month of July 2020. Temporary camp dismantles and surface leveling at powerhouse area has been completed. Structural concrete of tailrace has been completed. River protection works has been completed in the powerhouse area. Retaining wall about 153m has been completed. Stone soling work at the slope of retaining wall of powerhouse about 153m has been completed. Construction of the boundary wall and fencing work at the boundary on the periphery of the powerhouse and switchyard area is started in the month of September 2020 and the work is ongoing.

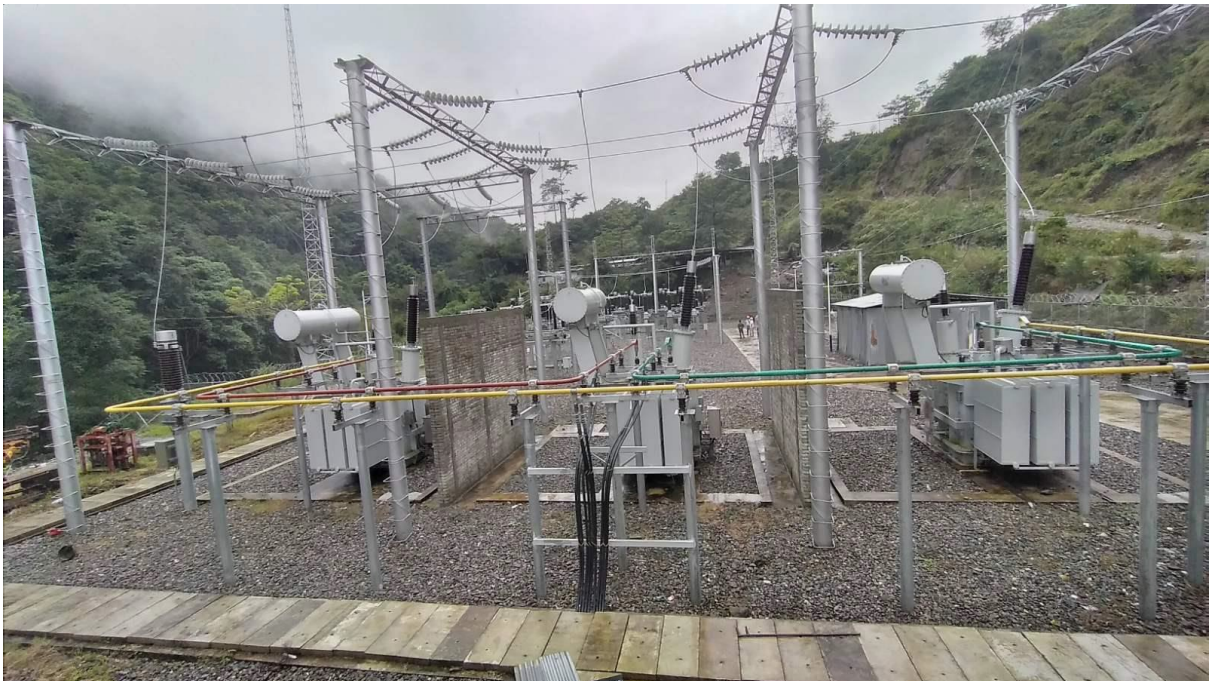
Figure 6: Switchyard Area after Completion of Electrical Works

Switch gear equipment has been completely installed in the month of May 2021, mean while internal wiring connection will be continued for upcoming two months.

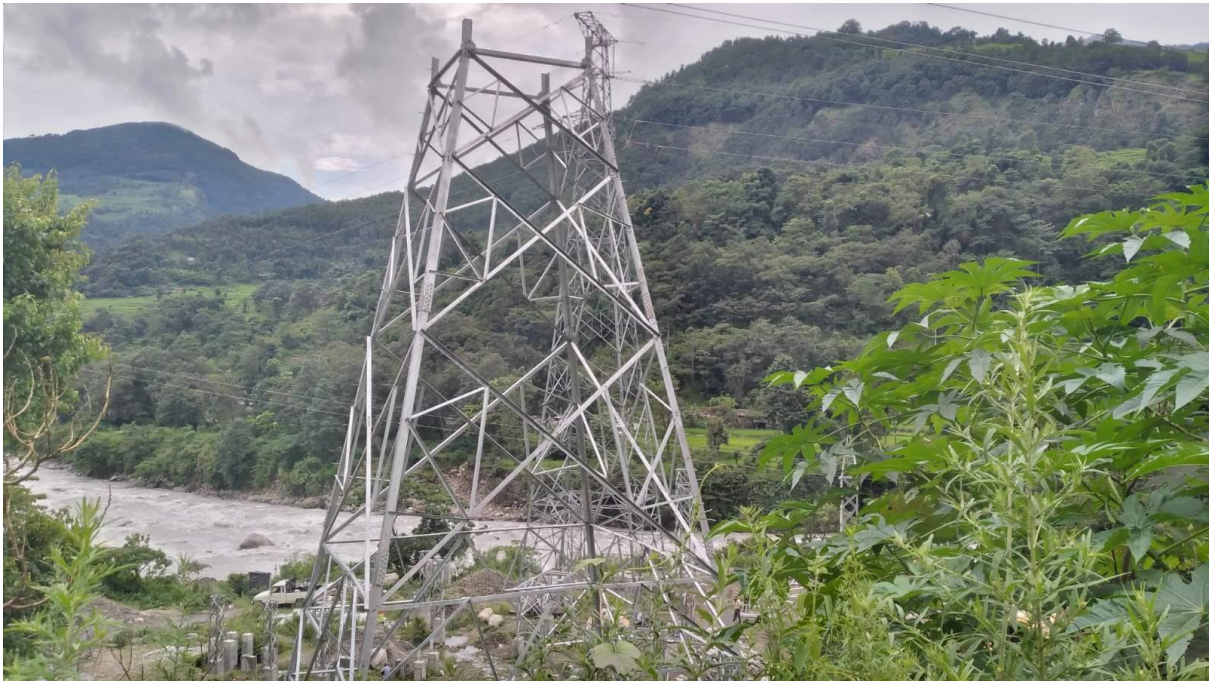
Figure 10: 132kV Transmission Line Tower Erection Work at Tower No. 25

Tower erection has been started on the month of October 2020. Erection of Towers T2, T3, T4, T5, T6, T7, T8, T9, T10, T11, T12, T13, T14, T16, T17, T18, T19, T20, T22, T23 and T24 has been completely erected till this month and installation of Tower no. T25 is ongoing.

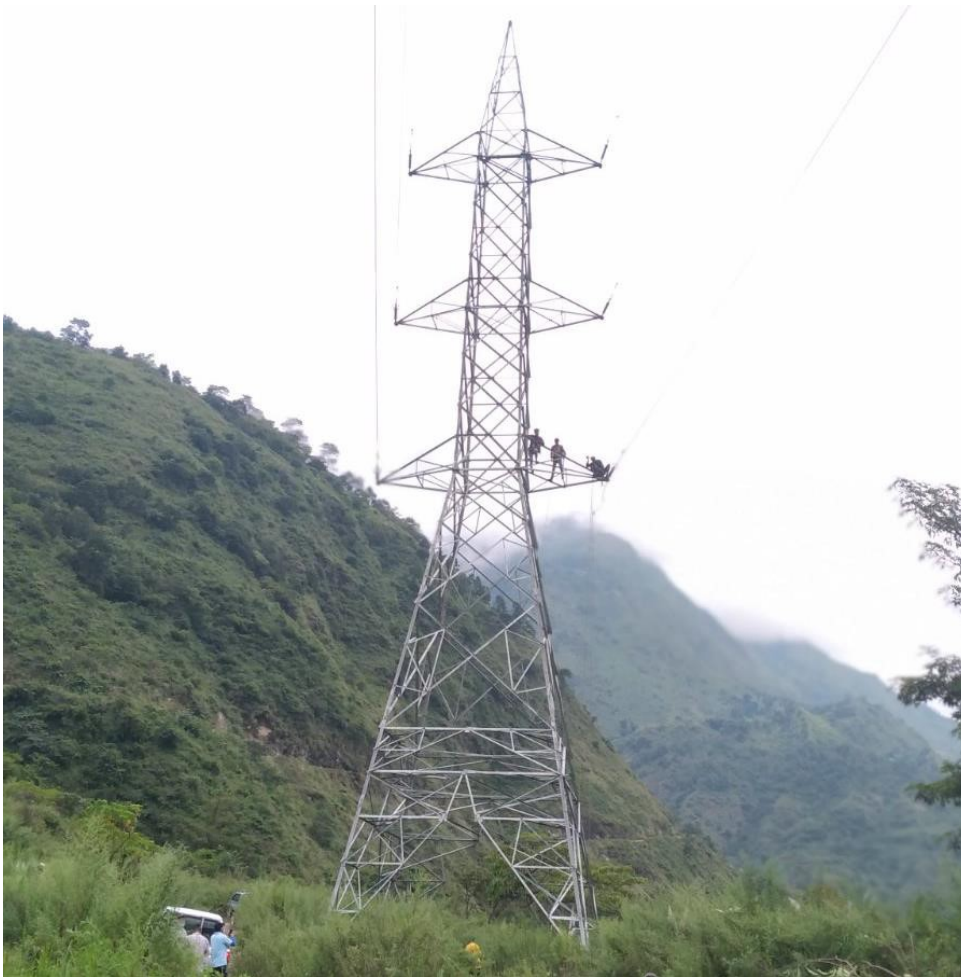
Figure 12: Conductor Stringing Work between the Tower no. 5 to 6

Erection of T1 and T2 interconnection point is remaining. Double circuit conductor stringing work has started from August 01 and in between tower nos. 2 to 4, 5 to 6 and 7 to 11 has been completed till this month; remaining work is ongoing.

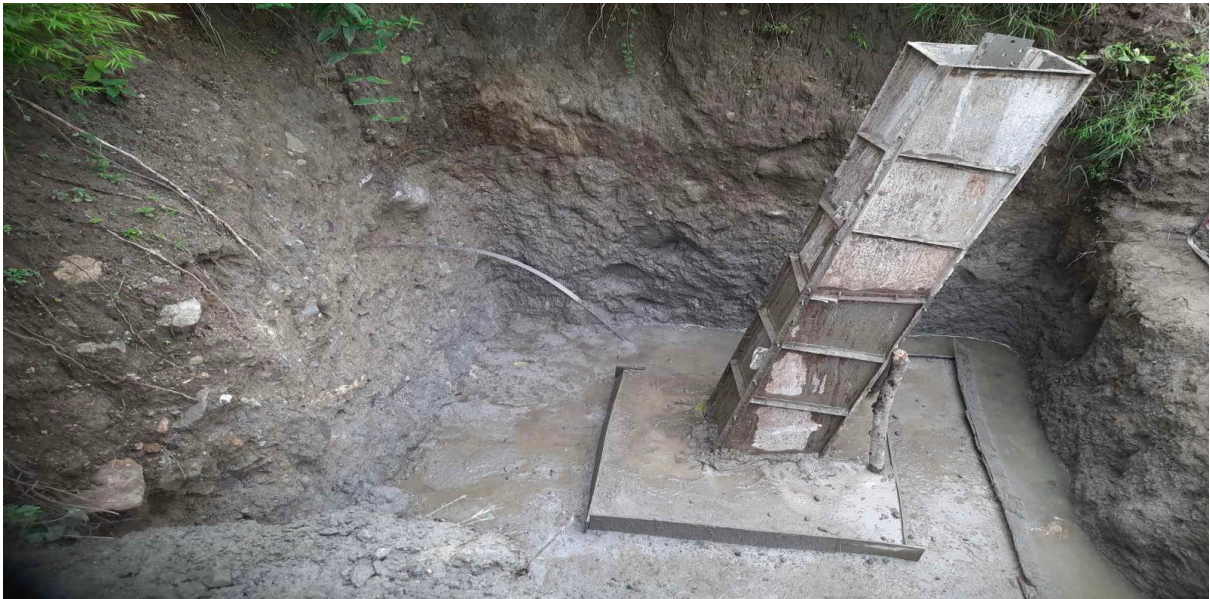
Figure 14: Concrete Work at the Foundation of Tower no. 1 of 132kV Transmission Line

Foundation works at tower no. 1 is ongoing.
